# Swarf staining

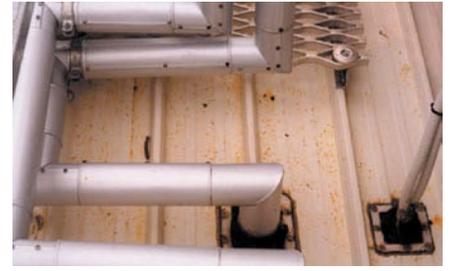
Figure 1. Swarf staining

Fresh swarf stains are characterised by small red-brown coloured areas with a central dark spot (the remains of the steel particles). The surface will feel like sandpaper, and the particle may be lifted with a fingernail. An old swarf stain will appear as a localised red-brown stain, the steel particle having corroded away, and the surface will be smoother.

Many swarf staining problems arise not only from installers, but also from following trades working in the vicinity (see Figure 1 for example). Architects, builders and project managers need to be aware of this possibility and warn contractors accordingly.

Brush the surface with a stiff bristle (not wire) brush to dislodge particles which must then be completely removed, not just swept into the gutter. Care should be taken to avoid removing any metallic coating. If the metallic coating is severely damaged by swarf corrosion, the affected area should be replaced, or overpainted following the recommendations contained in:

Clean the surface by washing with dilute mild household detergent and fresh water, then rinse well afterwards.

1. The affected area should be thoroughly waterblasted with clean fresh water using a pressure not exceeding 400psi (2760kPa).
2. Stubborn particles may be removed by use of a damp microfibre cloth (terry towelling cloths or sponges are not effective). More stubborn particles may require a plastic-bladed paint scraper, if used with care.
3. Upon completion again wash the roof to remove any dislodged particles, ensuring gutters are also rinsed.
