ACID CLEANING BRICKWORK

TECHNICAL BULLETIN CTB-15

Rev 3, November 2003

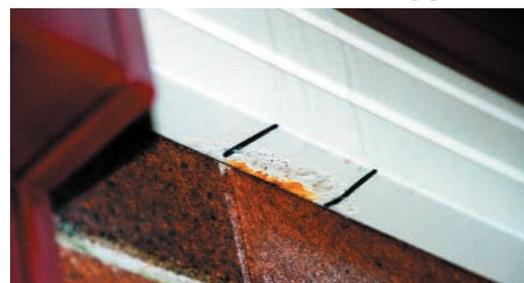
Acid cleaning of brickwork associated with two storey construction may pick up lead from lead flashings and re-deposit with sand from the mortar, within the roof gutters. Corrosion of the guttering rapidly follows.

Figure 1: Example of corrosion caused by incorrect acid brick cleaning practices.

BlueScope Steel Limited recommend that wherever possible acid cleaning should not be conducted subsequent to erection of metallic coated items. However, when this is not possible it is recommended that the areas be appropriately masked during the acid cleaning operation. Where the possibility of inundating the metallic item appears to be present, the item should be thoroughly wetted prior to the application of the acid to the adjacent brickwork. Immediately after acid application, the item should be thoroughly washed with water a number of times, working from the top of the brickwork to allow complete removal of the spent acid products.
