Acid cleaning brickwork

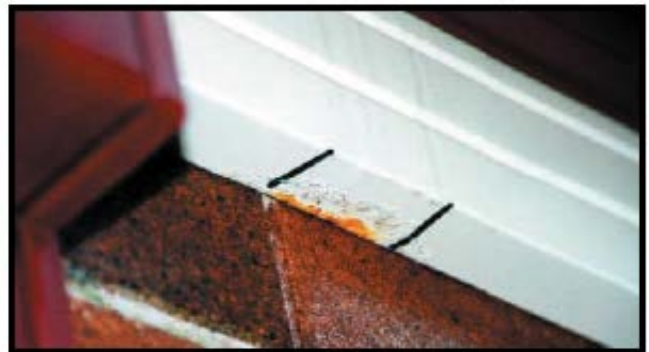
Acid cleaning of brickwork associated with two storey construction may pick up lead from lead flashings and re-deposit with sand from the mortar, within the roof gutters. Corrosion of the guttering rapidly follows.

Figure 1: Example of corrosion caused by incorrect acid brick cleaning practises.

BlueScope recommend that wherever possible acid cleaning should not be conducted subsequent to erection of metallic coated items. However, when this is not possible it is recommended that the areas be appropriately masked during the acid cleaning operation. Where the possibility of inundating the metallic item appears to be present, the item should be thoroughly wet prior to the application of the acid to the adjacent brickwork.

Immediately after acid application the item should be thoroughly washed from the top of the brickwork to allow complete removal of the spent acid products.
