Acid cleaning brickwork

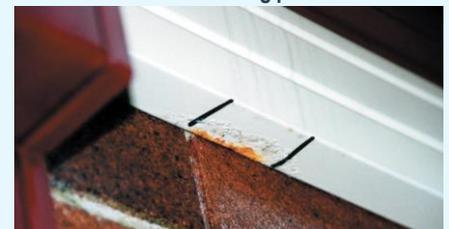
When brickwork is completed it is usual to clean excess mortar from the brick surface with a solution of one-part hydrochloric acid to 20 parts water. This ratio is often increased due to resistant mortar stains and/or inaccurate dosage control on the pressure cleaning units. This practice can create very corrosive conditions for downstream items such as steel guttering and fascia products, roller doors, meter boxes, metal door frames and window frames etc.

Many of the above items are fabricated from metallic coated steel, such as ZINCALUME® aluminium/zinc/magnesium alloy-coated steel and COLORBOND® prepainted steel. The forming of these items will lead to some cracking of the coating at the tension bends. This can result in the penetration of the acid to the substrate leading to a vigorous corrosive reaction.

Acid cleaning of brickwork associated with two-storey construction may lead to deposits of sand from the mortar and residual acid within the roof gutters. Corrosion of the guttering rapidly follows.

Figure 1: Example of corrosion caused by incorrect acid brick cleaning practices.

BlueScope recommends that, wherever possible, acid cleaning should not be conducted following the installation of metallic coated items. However, when this is not possible, it is recommended that the areas be appropriately masked during the acid cleaning operation. Where the possibility of inundating the metallic item exists, the item should be thoroughly wetted prior to the application of the acid to the adjacent brickwork. Immediately after acid application, the item should be thoroughly washed with water a

number of times, working from the top of the brickwork to allow complete removal of the spent acid products.
