## IMMERSION

### TECHNICAL BULLETIN CTB-16

Rev 4, November 2003

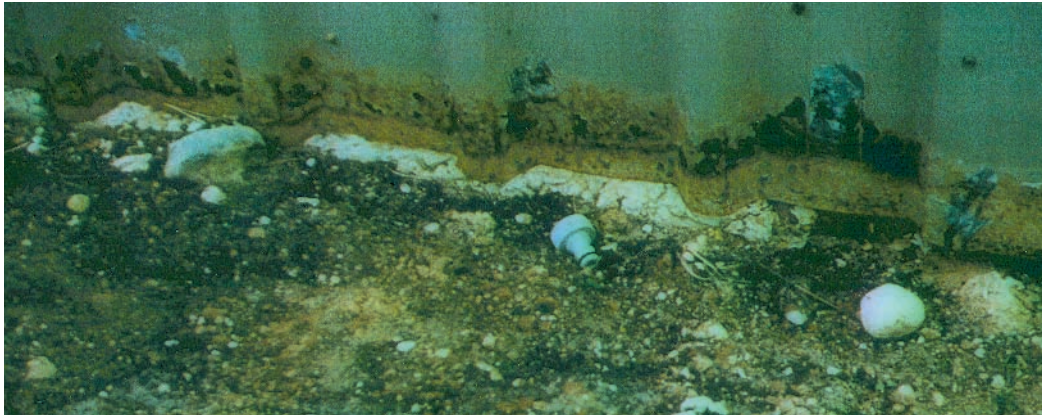
**Figure 1:** Immersed Shed Wall

In typical garden applications such as fence panels, garden sheds and walling the build up of grass cuttings, leaves, soil from gardens, mulch, compost, sand and ashes must be avoided. Failure to prevent this build up will cause premature corrosion of COLORBOND® steel, ZINCALUME® steel or galvanized steels as a direct result of mechanisms associated with the wet poultice held against the coated steel surface.

The construction of gardens adjacent to buildings or fencing by placing soil directly against ZINCALUME® steel or COLORBOND® steel is specifically not recommended as corrosion and perforation of the steel will rapidly occur about the point of immersion.
