CORROSION

FERTILIZER MANUFACTURING AND STORAGE BUILDINGS

TECHNICAL BULLETIN CTB-24

Rev 3, November 2003

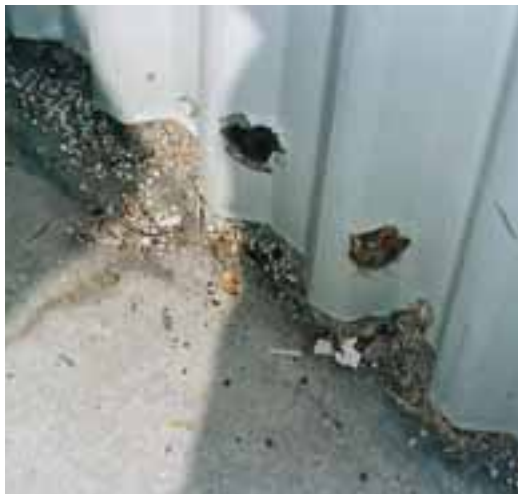
The manufacture of fertilizers utilises high concentrations of phosphorous, sulphur and chloride containing compounds along with other corrosive contaminants. Storage of the final fertilizer product in open piles, ie not in sealed bags, will also release these contaminants into the environment. The presence of these contaminants in the surrounding environment of a building will accelerate the corrosion of ZINCALUME® zinc/aluminium alloy coated steel, COLORBOND® prepainted steel and COLORBOND® Ultra prepainted steel.

Figure 1: Example of corrosion resulting from contact with fertilizer.

The broad spectrum of fertilizer products manufactured to meet the demands of the agriculture industry may expose the cladding material to a variety of fertilizer products during the service life of the building. Therefore, COLORBOND® Stainless prepainted steel is the only product recommended by BlueScope Steel Limited for roof and wall sheeting on fertilizer manufacturing and storage buildings.

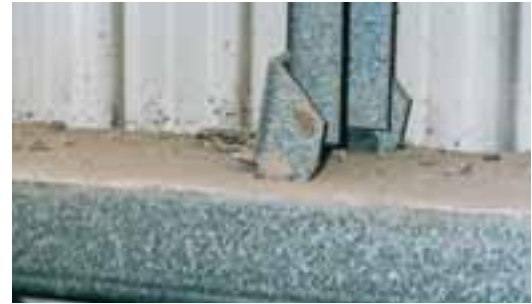
Figure 2: Build-up on purlin

As purlins are exposed to the same environment, BlueScope Steel recommend they be manufactured from GALVSPAN® Z450 steel and incorporate a turned-down lip to prevent the build-up of fertilizer dust. Furthermore, the purlins must be postpainted with an appropriate high-build industrial paint system as recommended by a reputable paint supplier.

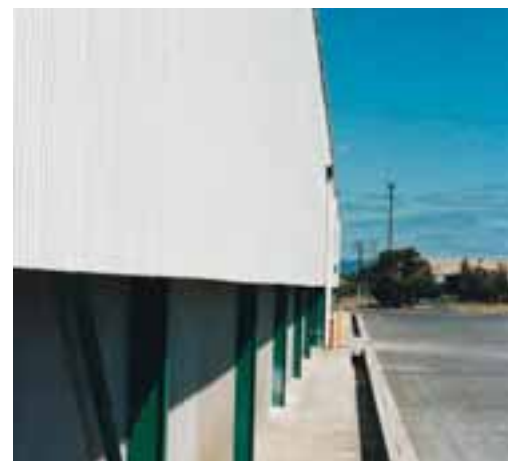
Experience has shown that the incorporation of a masonry dwarf wall can dramatically reduce the instance of mechanical damage and corrosion to wall cladding. This avoids direct contact between the fertilizer and the cladding.

Figure 3: Example of a dwarf wall
