Fertiliser manufacturing and storage buildings

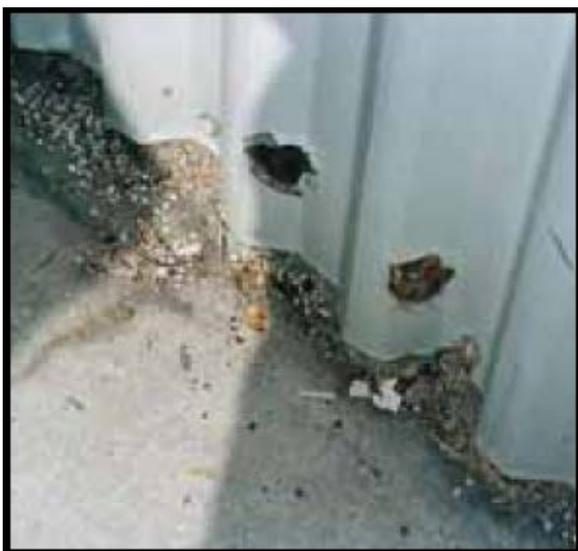
The manufacture of fertilisers utilises high concentrations of phosphorus, sulphur and chloride containing compounds along with other corrosive contaminants. Storage of the final fertiliser product in open piles i.e. not sealed bags, will also release these contaminants into the environment. The presence of these contaminants in the surrounding environment of a building will accelerate the corrosion of ZINCALUME® steel, COLORBOND® steel and COLORBOND® Ultra steel.

Figure 1: Example of corrosion resulting from contact with fertiliser.

The broad spectrum of fertiliser products manufactured to meet the demands of the agriculture industry may expose the cladding material to a variety of fertiliser products during the service life of the building. Therefore, COLORBOND® Stainless steel is the only product recommended by BlueScope for roof and wall sheeting on fertiliser manufacturing and storage buildings.

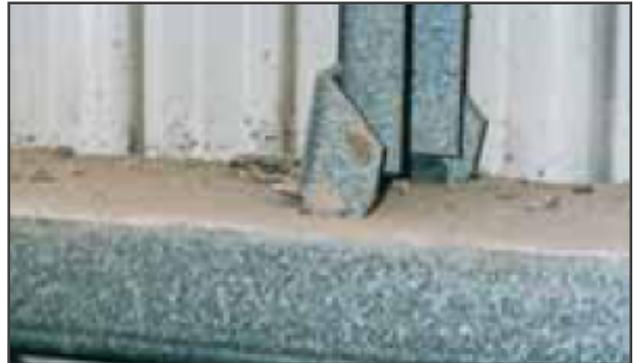
Figure 2: Build-up on a purlin.

As purlins are exposed to the same environment, BlueScope recommend they be manufactured from GALVSPAN® Z450 steel and incorporate a turned-down lip to prevent the build up of fertiliser dust. Furthermore, the purlins must be post-painted with an appropriate high-build industrial paint system as recommended by a reputable paint supplier.

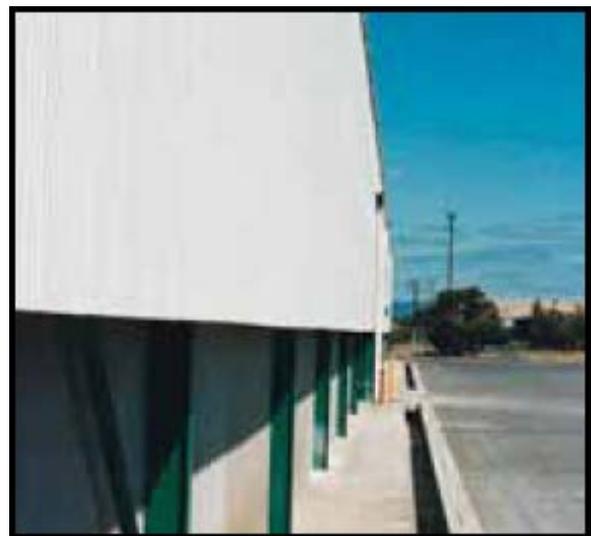
Experience has shown that the incorporation of a masonry dwarf wall can dramatically reduce the instance of mechanical damage and corrosion to wall cladding. This avoids direct contact between the fertiliser and the cladding.

Figure 3: Example of a dwarf wall.
