Cut edge and bend protection of next generation ZINCALUME® aluminium/zinc/magnesium alloy-coated steel and COLORBOND® prepainted steel with Activate™ technology

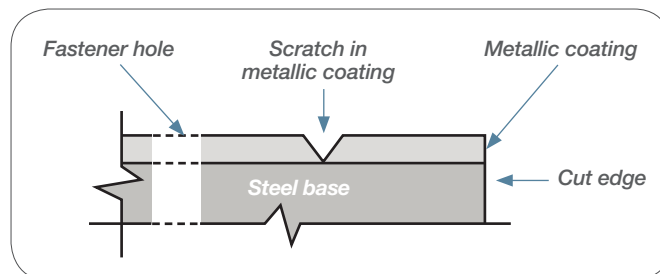
Figure 1: Schematic of a cut edge (not to scale).

Unprotected edges are created on coated steel products when the sheet is cut or pierced. Examples include when roofing or walling is cut to length or when holes are made in the steel to accommodate fasteners. It is normal practice to have edges that have been slit, sheared, drilled or cut on site using a cold cutting saw. *Figure 1* shows a schematic of a cut edge.

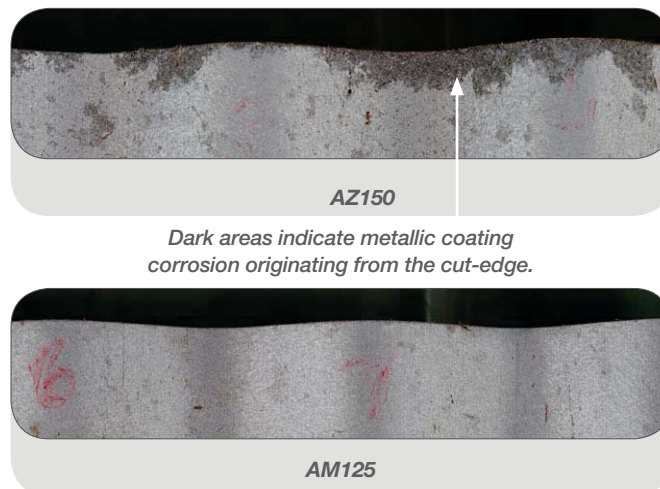
Figure 2: Unpainted sheltered walling (i.e. unwashed) in a severe marine environment after 50 months.

NOTE:
The samples shown in *Figure 2* have been tested in a severe environment to accelerate corrosion rates. Use of the product in this location is not recommended by BlueScope Steel.

For unpainted products, a combination of both coating mass and coating type determine how effectively a metallic coating is able to protect cut edges. In general, within a particular coating type, it can be said that the higher the coating mass, the greater the level of protection (e.g. AM150 provides a greater level of protection than AM125). However, different coating types can also have significantly different levels of protection. For example, next generation ZINCALUME® steel with Activate™ technology provides a more effective means for protecting cut edges, therefore AM125 is capable of providing better cut edge protection than AZ150. For further details about corrosion protection mechanisms, see [Corrosion Technical Bulletin CTB-6](#) *Development of aluminium/zinc/magnesium alloy coating for next generation ZINCALUME® steel with Activate™ technology*. *Figures 2 and 3* demonstrate the greater effectiveness of cut edge protection by using AM125 metallic coating compared to AZ150 metallic coating.

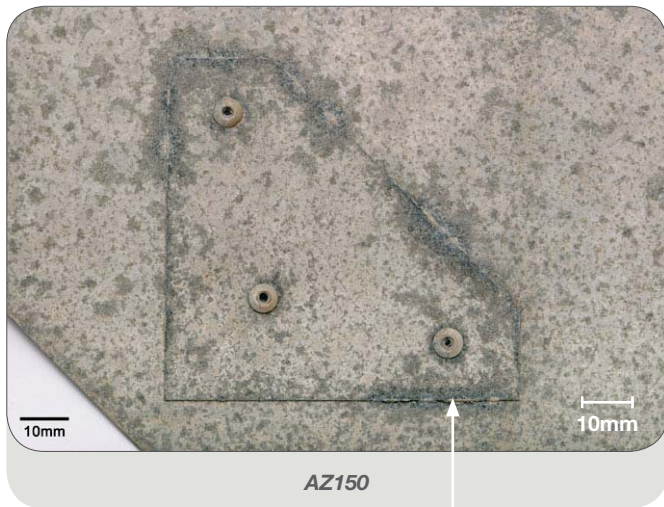
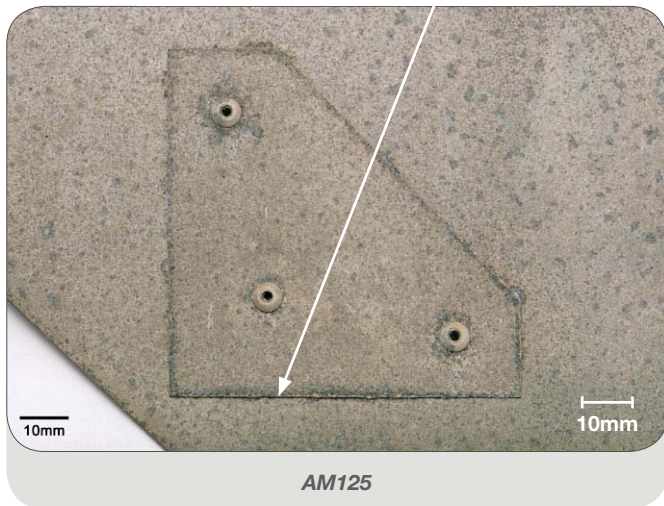
Figure 3: Unpainted panels tested in a sheltered (i.e. unwashed) position in a severe marine environment after 66 months.

Dark areas indicate metallic coating corrosion originating from the cut-edge.

The samples shown in Figure 3 have been tested in a severe environment to accelerate corrosion rates. Use of the product in this location is not recommended by BlueScope Steel.

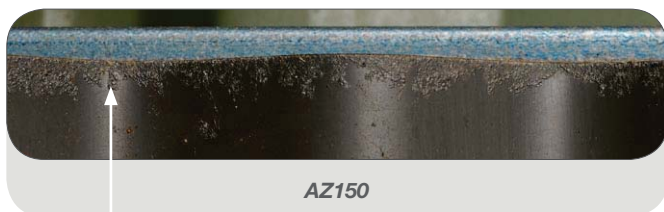
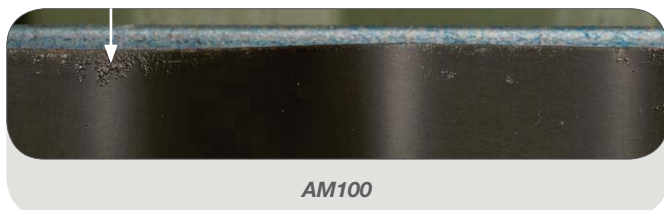
Figure 4: Prepainted sheltered walling (i.e. unwashed) in a severe marine environment after 50 months.

Blisters developed from cut-edge protection.

The samples shown in Figure 4 have been tested in a severe environment to accelerate corrosion rates. Use of the product in this location is not recommended by BlueScope Steel.

Combinations of metallic coating mass and type are the primary factors in determining the effectiveness of cut edge protection of prepainted metallic coated steel products. A by-product of cut edge protection is the development of metal oxides beneath the paint surface resulting in small paint blisters. This is known as “edge undercutting”.

While prepainted AZ150 provides excellent cut edge protection, next generation COLORBOND® steel with Activate™ technology provides an even more effective means for protecting cut edges. A reduction in metallic coating is able to be achieved without compromising the corrosion resistance at the cut edges of the prepainted product. This is illustrated in Figure 4.

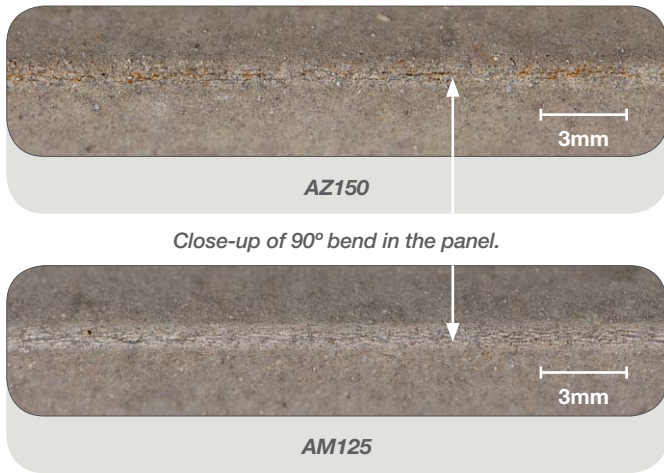
Figure 5: Close-up photographs of the 90° bend of unpainted samples exposed in a marine environment after 18 months (washed).

NOTE:
The samples shown in Figure 5 have been tested in a severe environment to accelerate corrosion rates. Use of the product in this location is not recommended by BlueScope Steel.

Extensive test programs have shown that the enhanced corrosion protection provided by the AM coating maintains either equivalent or superior field corrosion performance compared with AZ, even if the surface has superficial cracking. Figures 5 and 6 show samples that have been tested outdoors in marine environments to determine the difference in bend corrosion performance between AZ and AM.

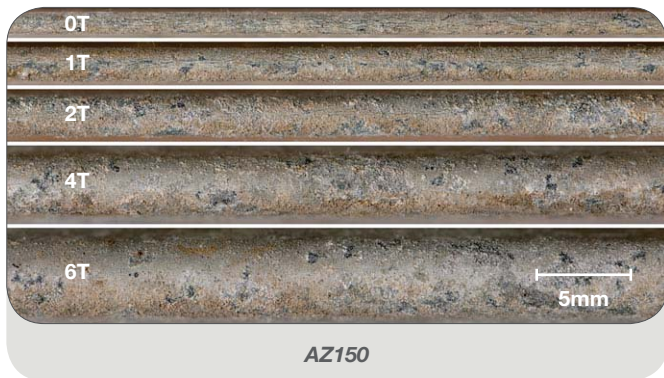
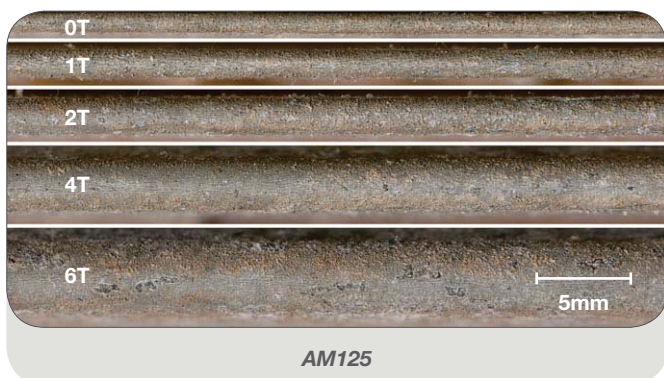
Figure 6: Unpainted samples of AZ and AM with various bend diameters, exposed in a sheltered (i.e. unwashed) severe marine environment for 45 months.

NOTE:
The samples shown in Figure 6 have been tested in a severe environment to accelerate corrosion rates. Use of the product in this location is not recommended by BlueScope Steel.

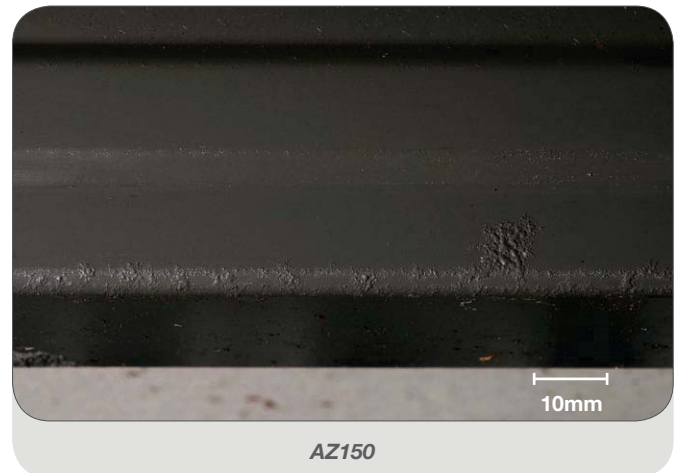
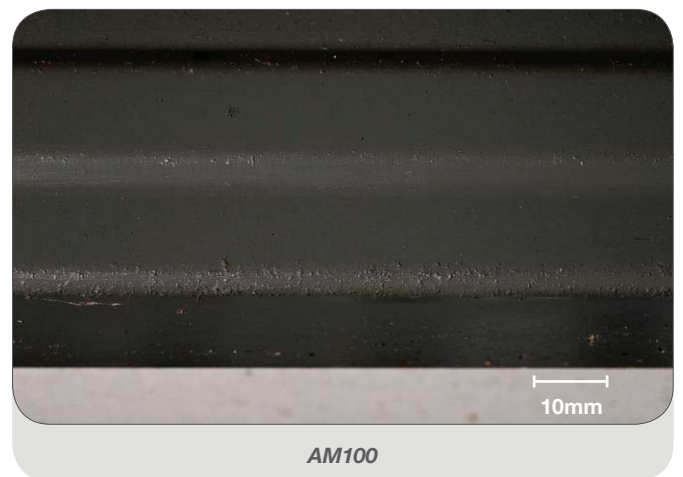
Figure 7: Prepainted, sheltered fascia bends (i.e. unwashed) after 57 months exposure within 100m from breaking surf on an outdoor test facility.

NOTE:
The samples shown in Figure 7 have been tested in a severe environment to accelerate corrosion rates. Use of the product in this location is not recommended by BlueScope Steel.

Bend corrosion performance on prepainted products is most relevant to applications with relatively tight bends that are also in unwashed areas. Figure 7 shows fascia samples of prepainted AZ150 and AM100 that have been tested in a severe marine environment for 57 months. Both samples show a number of very small blisters (visible at 10x magnification), with additional intermittent larger blisters on the AZ150 product. It is important to note that the level of blistering seen in Figure 7 is not typically observed on either AZ or AM alloy coated steels in less severe environments.

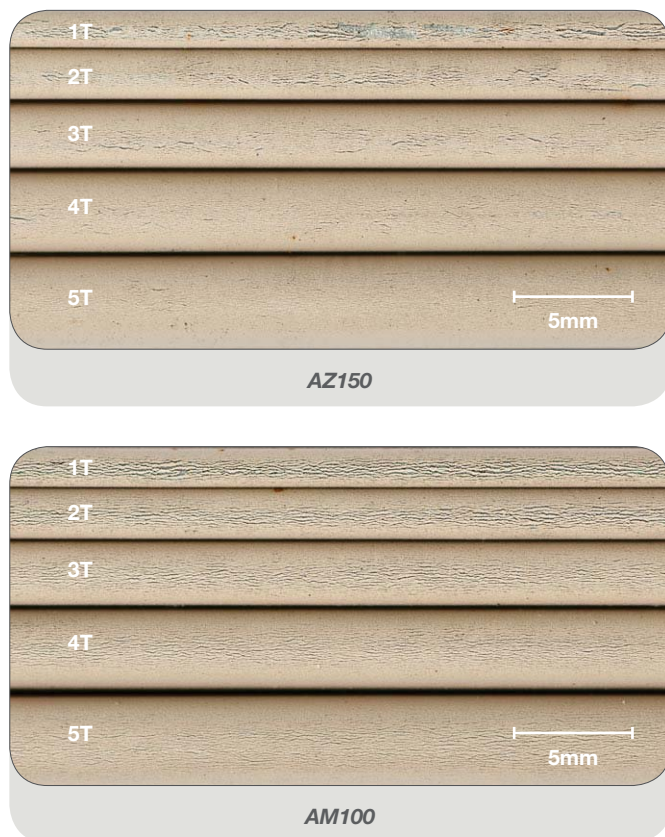
Figure 8: Prepainted bend samples exposed in an unwashed marine environment for 51 months.

Figure 8 shows the results of a test to determine the corrosion performance of prepainted AZ150 and AM100 with a range of bend radii, exposed for 51 months in an unwashed marine environment. Whilst there is slightly more cracking on the AM100 product, there is a minimal corrosion on either the AZ150 or AM100.
