Prevention of sunscreen damage

To ensure you have the most current Technical Bulletin

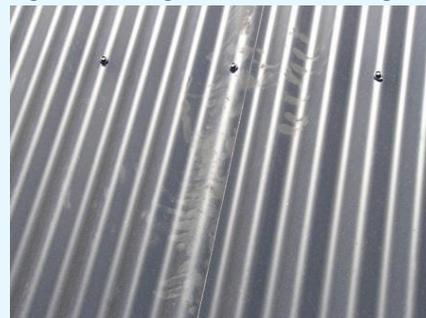
Clear or nanoparticle inorganic sunscreen formulations are marketed as 'non-whitening' to skin. TiO₂ and ZnO nanoparticles within inorganic sunscreen formulations function as UV absorbers and become 'photocatalysts' producing free radicals. Free radicals can generate sufficient chemical reactions that are very aggressive and can damage paint systems much faster than normal weathering.

Figure 1: Roofing with sunscreen damage.

Although sunscreen damage is irreversible it will not affect the corrosion performance of the material. The sunscreen affected areas cannot be cleaned and attempts to do so may ultimately impact on the corrosion performance of the material. If aesthetics are a concern, BlueScope recommends that the material be replaced.

- wear clean, dry, cut-resistant gloves that are suitable for the task;
- take suitable precautions against personal sun damage; and
- prevent contact of the painted surface with sunscreens that contain titanium dioxide (TiO₂) and zinc oxide (ZnO)

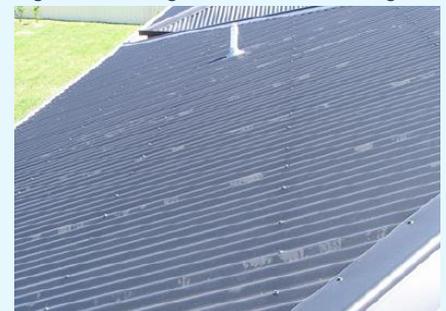
Figure 2: Roofing with sunscreen damage
