Prevention of sunscreen damage

To ensure you have the most current Technical Bulletin

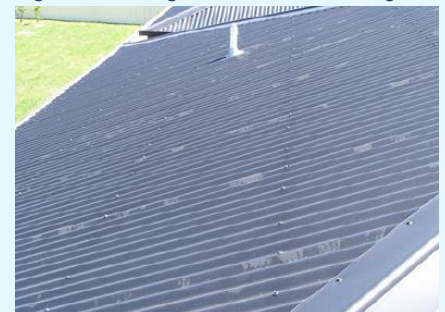
Figure 2: Roofing with sunscreen damage

Although sunscreen damage is irreversible it will not affect the corrosion performance of the material. The sunscreen affected areas cannot be cleaned and attempts to do so may ultimately impact on the corrosion performance of the material. If aesthetics are a concern, BlueScope recommends that the material be replaced.
