Flashing materials for COLORBOND® steel and ZINCALUME® steel sheet

Technical Bulletin 8

May 2019. Revision 9.
This issue supersedes all previous issues.

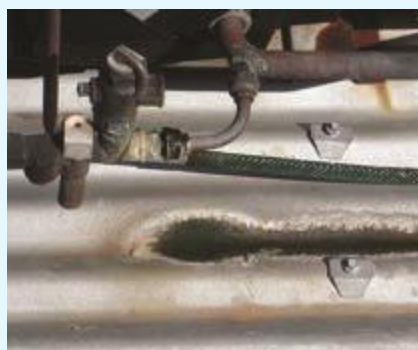
Bi-metallic corrosion of COLORBOND® steel and ZINCALUME® steel occurs when these products are in direct contact with copper, and from contact with “copper-rich” water run-off e.g. hot water system overflows (see Figure 1).

Figure 1: Bi-metallic corrosion caused by ‘copper-rich’ water run-off

Painting the outside of copper piping is recommended. Hot water discharge pipes should be extended beyond the roof, preferably to the ground.
